Avalanche Hazard Reduction for Transportation Corridors Using Real-time Detection and Alarms

Robert Rice Jr., Rand Decker, Newel Jensen, Ralph Patterson, Stanford Singer, (1) and Clayton Sullivan (2), LeRoy Wells (3)

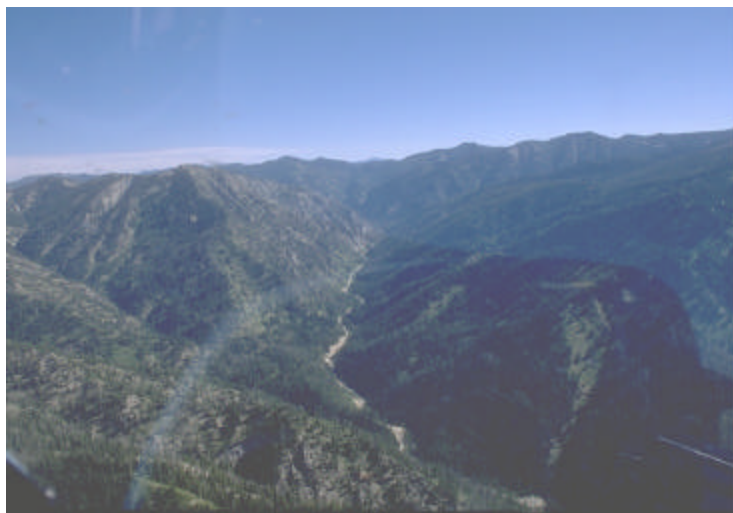
Figure 3 Aerial view of Canyon Creek section of SH 21, Idaho.

The Canyon Creek section of Idaho State Highway 21 passes through a hazardous corridor consisting of numerous avalanche paths (See Figure 3). Fifty-six avalanche paths cross the highway in the 14-kilometer (9 miles) section between mileposts 96 and 105. The average frequency which any particular avalanche hits the highway ranges from 0.03 to 2.5 occurrences per year (Unpublished data from D. Bowles, 1988).

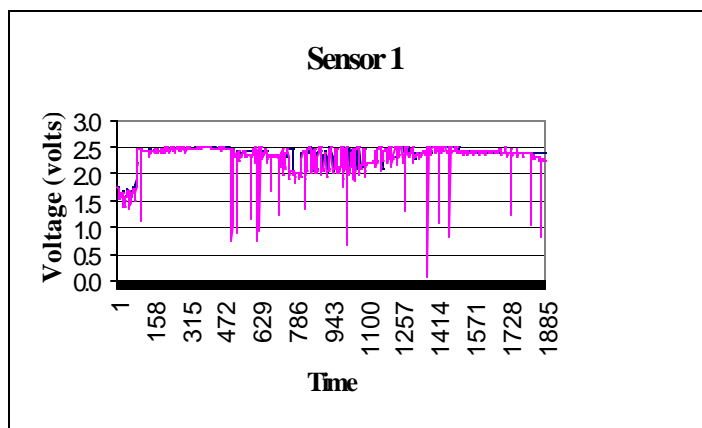
Figure 5 Voltage-Time History from 1997/98 SH 21, Idaho-avalanche path 96.92 sensor 1.

In March the data was manually downloaded from avalanche path 100. The data was analyzed for completeness and accuracy. Figure 6 represent graphical a typical data set for the 1998/99-winter season at avalanche path 100. A spike of 2.0 to 2.5 volts in Figure 6 represents the sensor reaching an angle of 90 degrees from plum, thereby indicating the possibility of an avalanche. The sensors at slide path 100 were redesigned to eliminate the noise associated with the data sets as represented in Figure 5 at avalanche 96.92.

The results from avalanche path 96.92 indicate the sensors and the datalogger/controller were operational, except during a four-week period in November/December. The sensor values in Figure 5 range between 0.5 and 2.5 volts (The drift in the signal is associated with the position of the mercury switch in the galvanized steel pipe. This problem is corrected by repositioning the mercury switch to read 2.0 to 2.5 volts for an event. These corrections were made to the sensors at avalanche path 100 on SH 21 and Cow of the Woods in Wyoming. Neither configuration is fail safe, but data interpretation becomes less confusing when identifying events.). Therefore, no avalanche or false alarms were recorded at the remote site. When the sensors record a reading of 0.0 an event has occurred. This is indicative of the sensor reaching an angle of 90 degrees and a completed circuit in the sensor. These findings collaborate with ITD observations of avalanche path 96.92 during the winter of 1997/98.

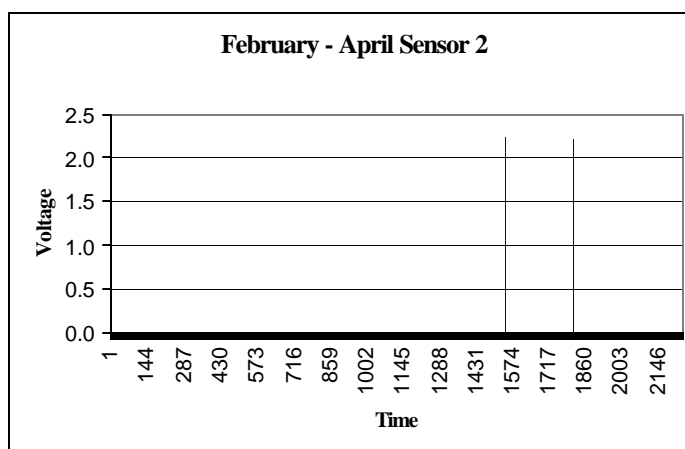
Figure 7 Voltage-Time History from 1999 US Highway 189, Wyoming sensor 2.

During the 1998/99-winter season WyDOT personnel observed avalanches between January, February, and April. These avalanches were naturally and artificially initiated. Figures 7 graphical represent a data set recorded by the datalogger from February–April 1999. A spike of 2.0 to 2.5 volts represents events. The event recorded by sensor 2 in Figure 7 on April 7, 1999 was initiated by manual excitation of the sensors by W/AEL personnel. The event of April 18, 1999 was an avalanche artificially released by WyDOT avalanche crews using artillery.

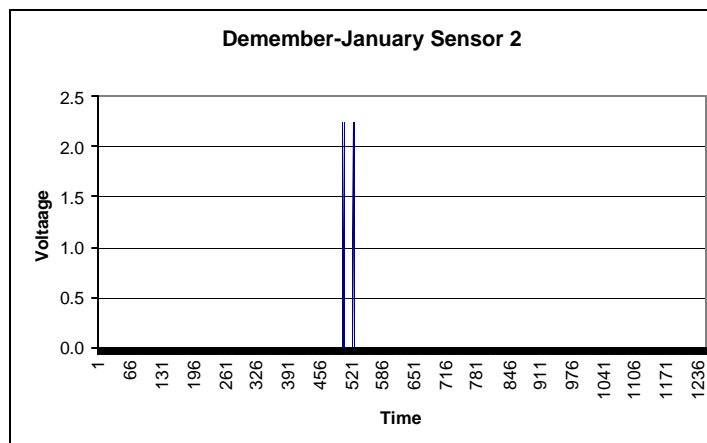
Figure 9 Voltage-Time History from 1999/2000 US Highway 189 Cow of the Woods, Wyoming sensor 2.

The system was operational by December 1999. The sensors at the Cow of the Woods avalanche path recorded three events during a January 2000 storm cycle. These three events are recorded in Table 2 and represented graphical in Figure 9. The first event was a natural avalanche that hit the road. The lights were activated at the roadway. WyDOT maintenance crews were notified and road clearance operations were initiated. The second and third event on January 11 and 12, 2000 was a false negative (an avalanche that reached the roadway without triggering flasher lighted road signs and/or in vehicle audio alarm boxes) and a false positive (an

The early season results at the Cow of the Woods avalanche path indicate the system was operational and was functioning adequately. The first event on January 11, 2000 captured the avalanche event and via road signs warned on-coming traffic of roadway avalanche debris. Since WyDOT maintenance crews were not present in Hoback Canyon the in vehicle alarm boxes were not tested. The second event captured by the detection system was a false negative. The avalanche reached the roadway, depositing 0.15 meters of debris on the highway. WyDOT maintenance crews were unable to identify whether the avalanche initiated above or below the sensors due to poor visibility. Also, the possibility exists that the avalanche traveled underneath the sensors, due to the wet nature and volume of the debris on the road. The third triggered event was a false positive. Again, due to poor visibility, WyDOT maintenance crews suspect high winds triggered this event. Wind speeds at the time of the false positive were recorded at ~ 27
